Township of Oro-Medonte Communal Tile Fields Performance Report 2025

Horseshoe Valley Municipal Communal Tile Fields & Sewage Collection Systems Annual Report

Period Covering: January 1, 2025 to December 31, 2025

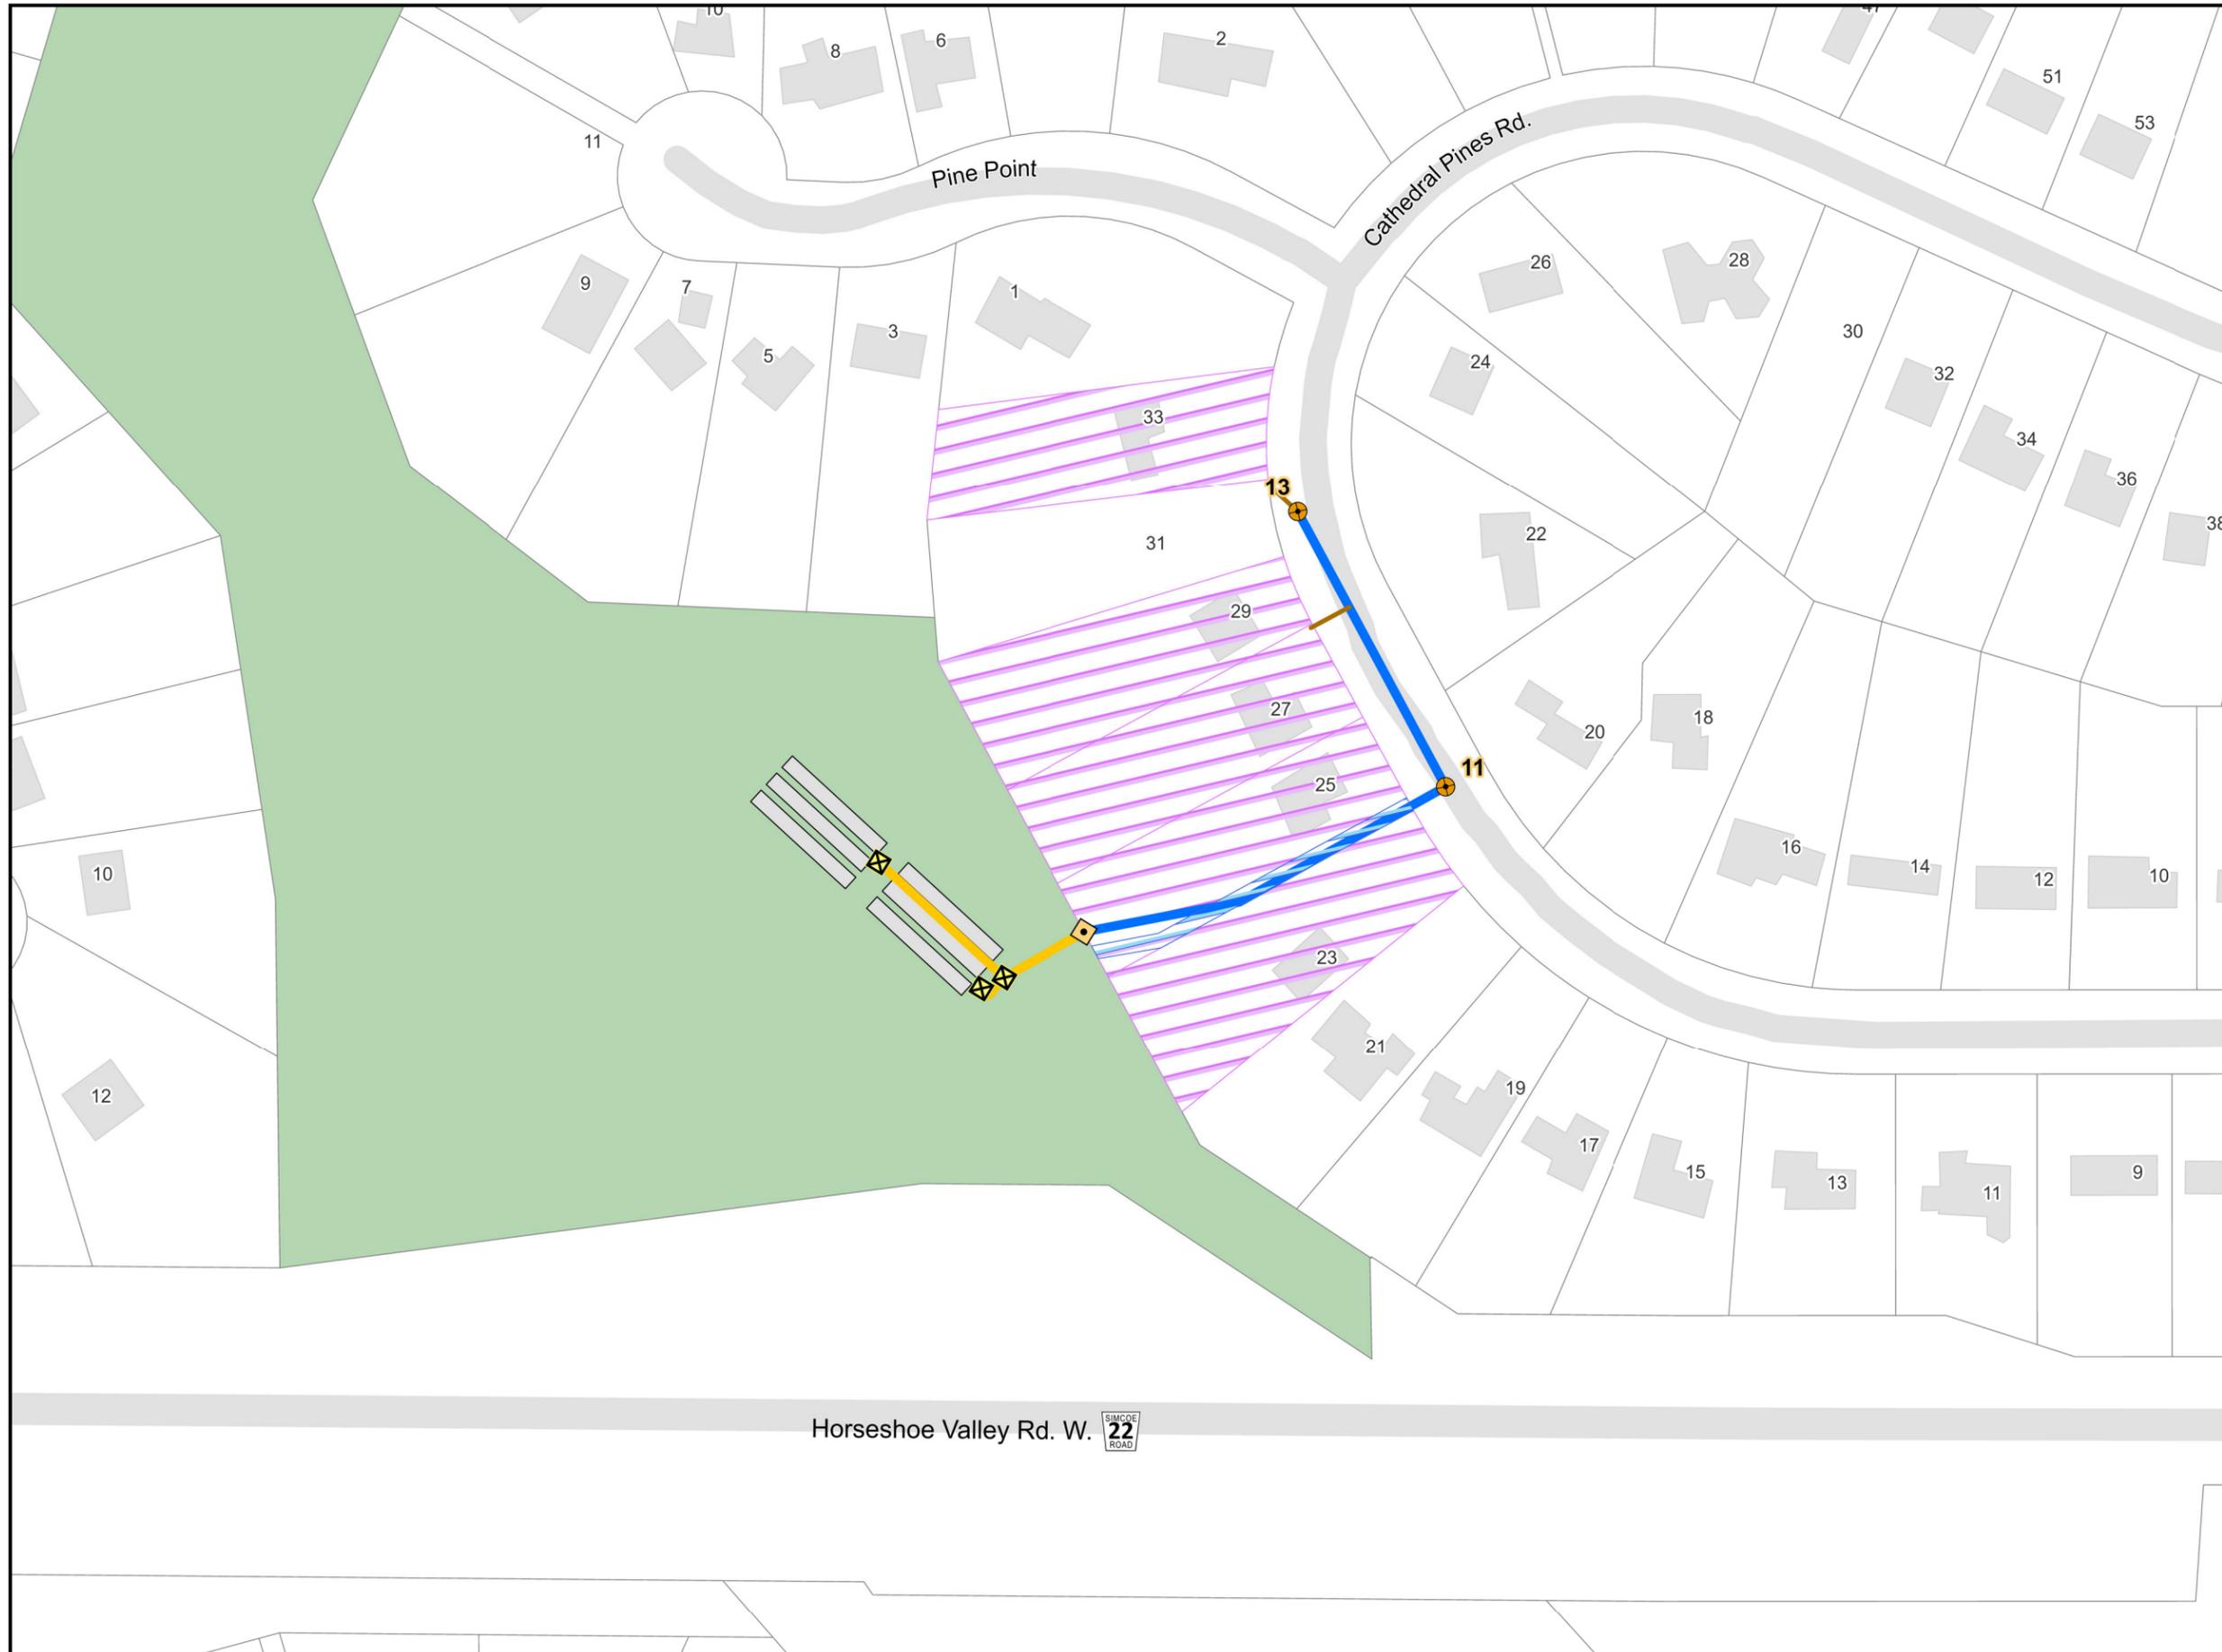
Wastewater System Plan
Tile Field 1
 January 2025

Communal Tile Field 1 is located behind 23, 25, 27, and 29 Cathedral Pines Road and services five (5) properties, each equipped with its own septic tank that provides primary treatment. Effluent from these private septic tanks flows into the associated municipal collection system and is conveyed to the communal tile field for subsurface disposal through a siphon/dosing chamber and leaching bed. The collection system includes approximately 237 metres of gravity sanitary sewer main and two maintenance holes.

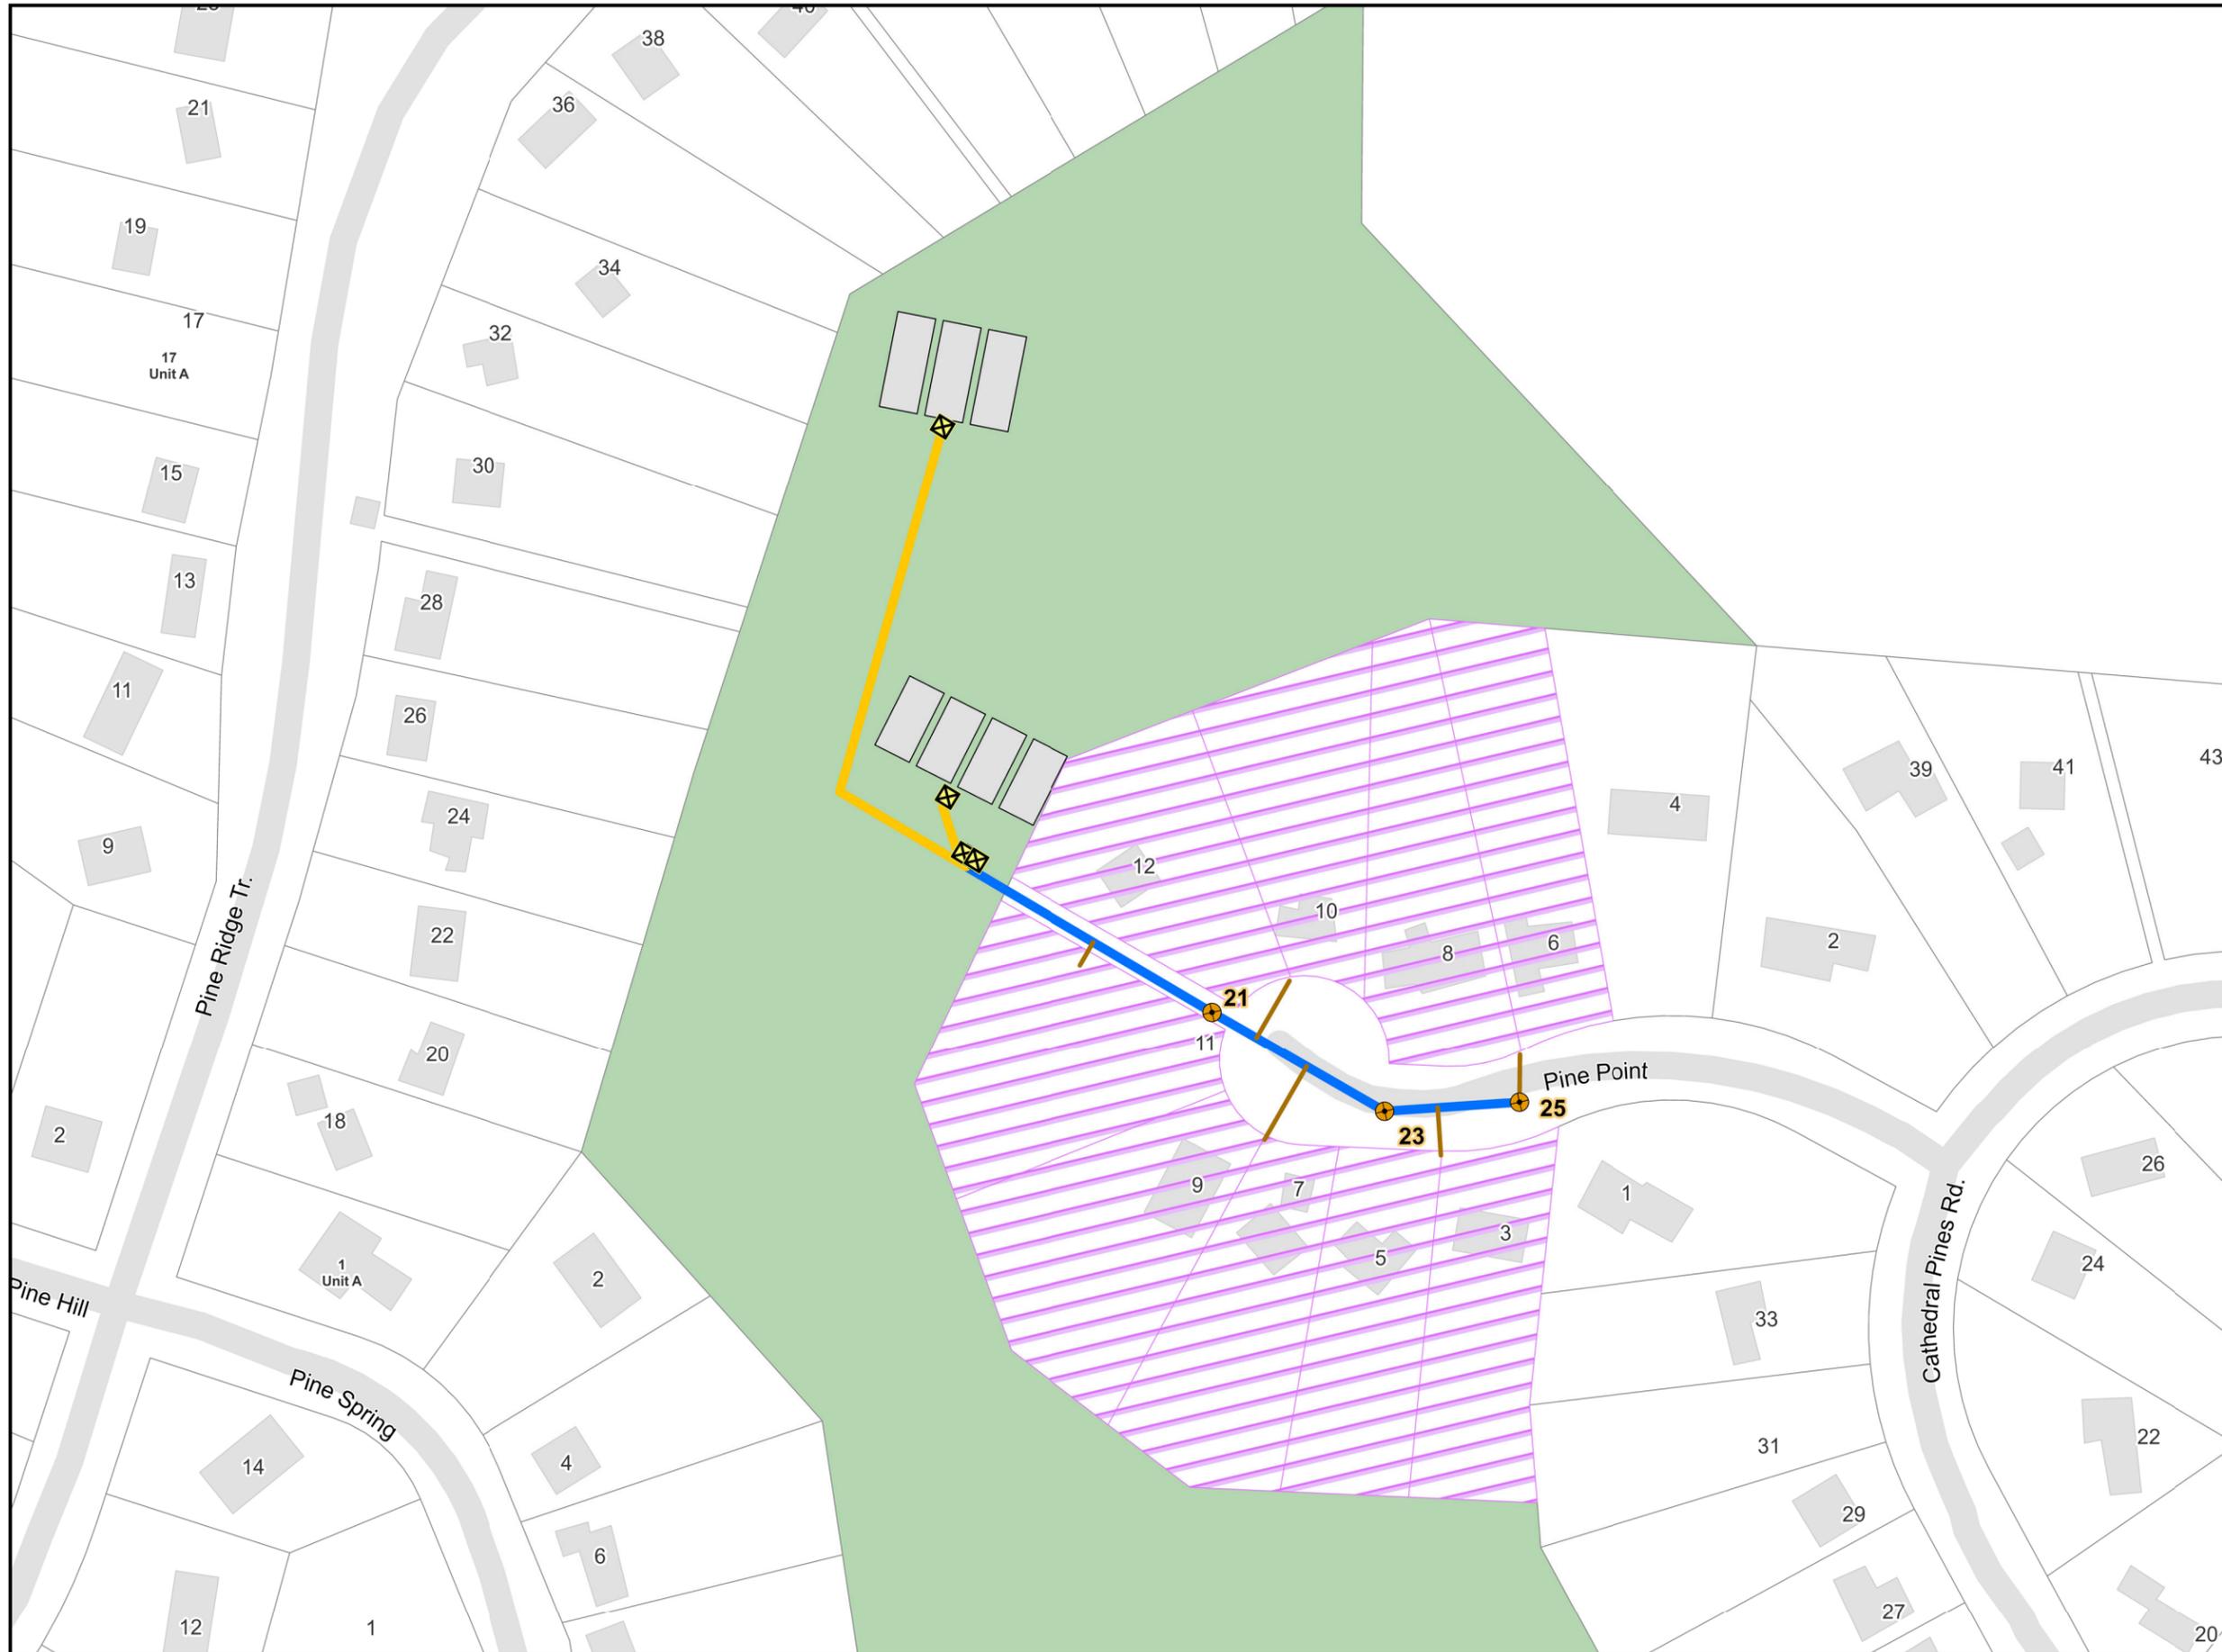
Wastewater System Plan
Tile Field 2
 January 2025

Communal Tile Field 2 is located behind 12 Pine Point Road and services nine (9) properties, each equipped with its own septic tank that provides primary treatment. Effluent from these private septic tanks flows into the associated municipal collection system and is conveyed to the communal tile field for subsurface disposal through a siphon/dosing chamber and leaching bed. The collection system includes approximately 285.5 m of gravity sanitary sewer main and 3 maintenance holes.

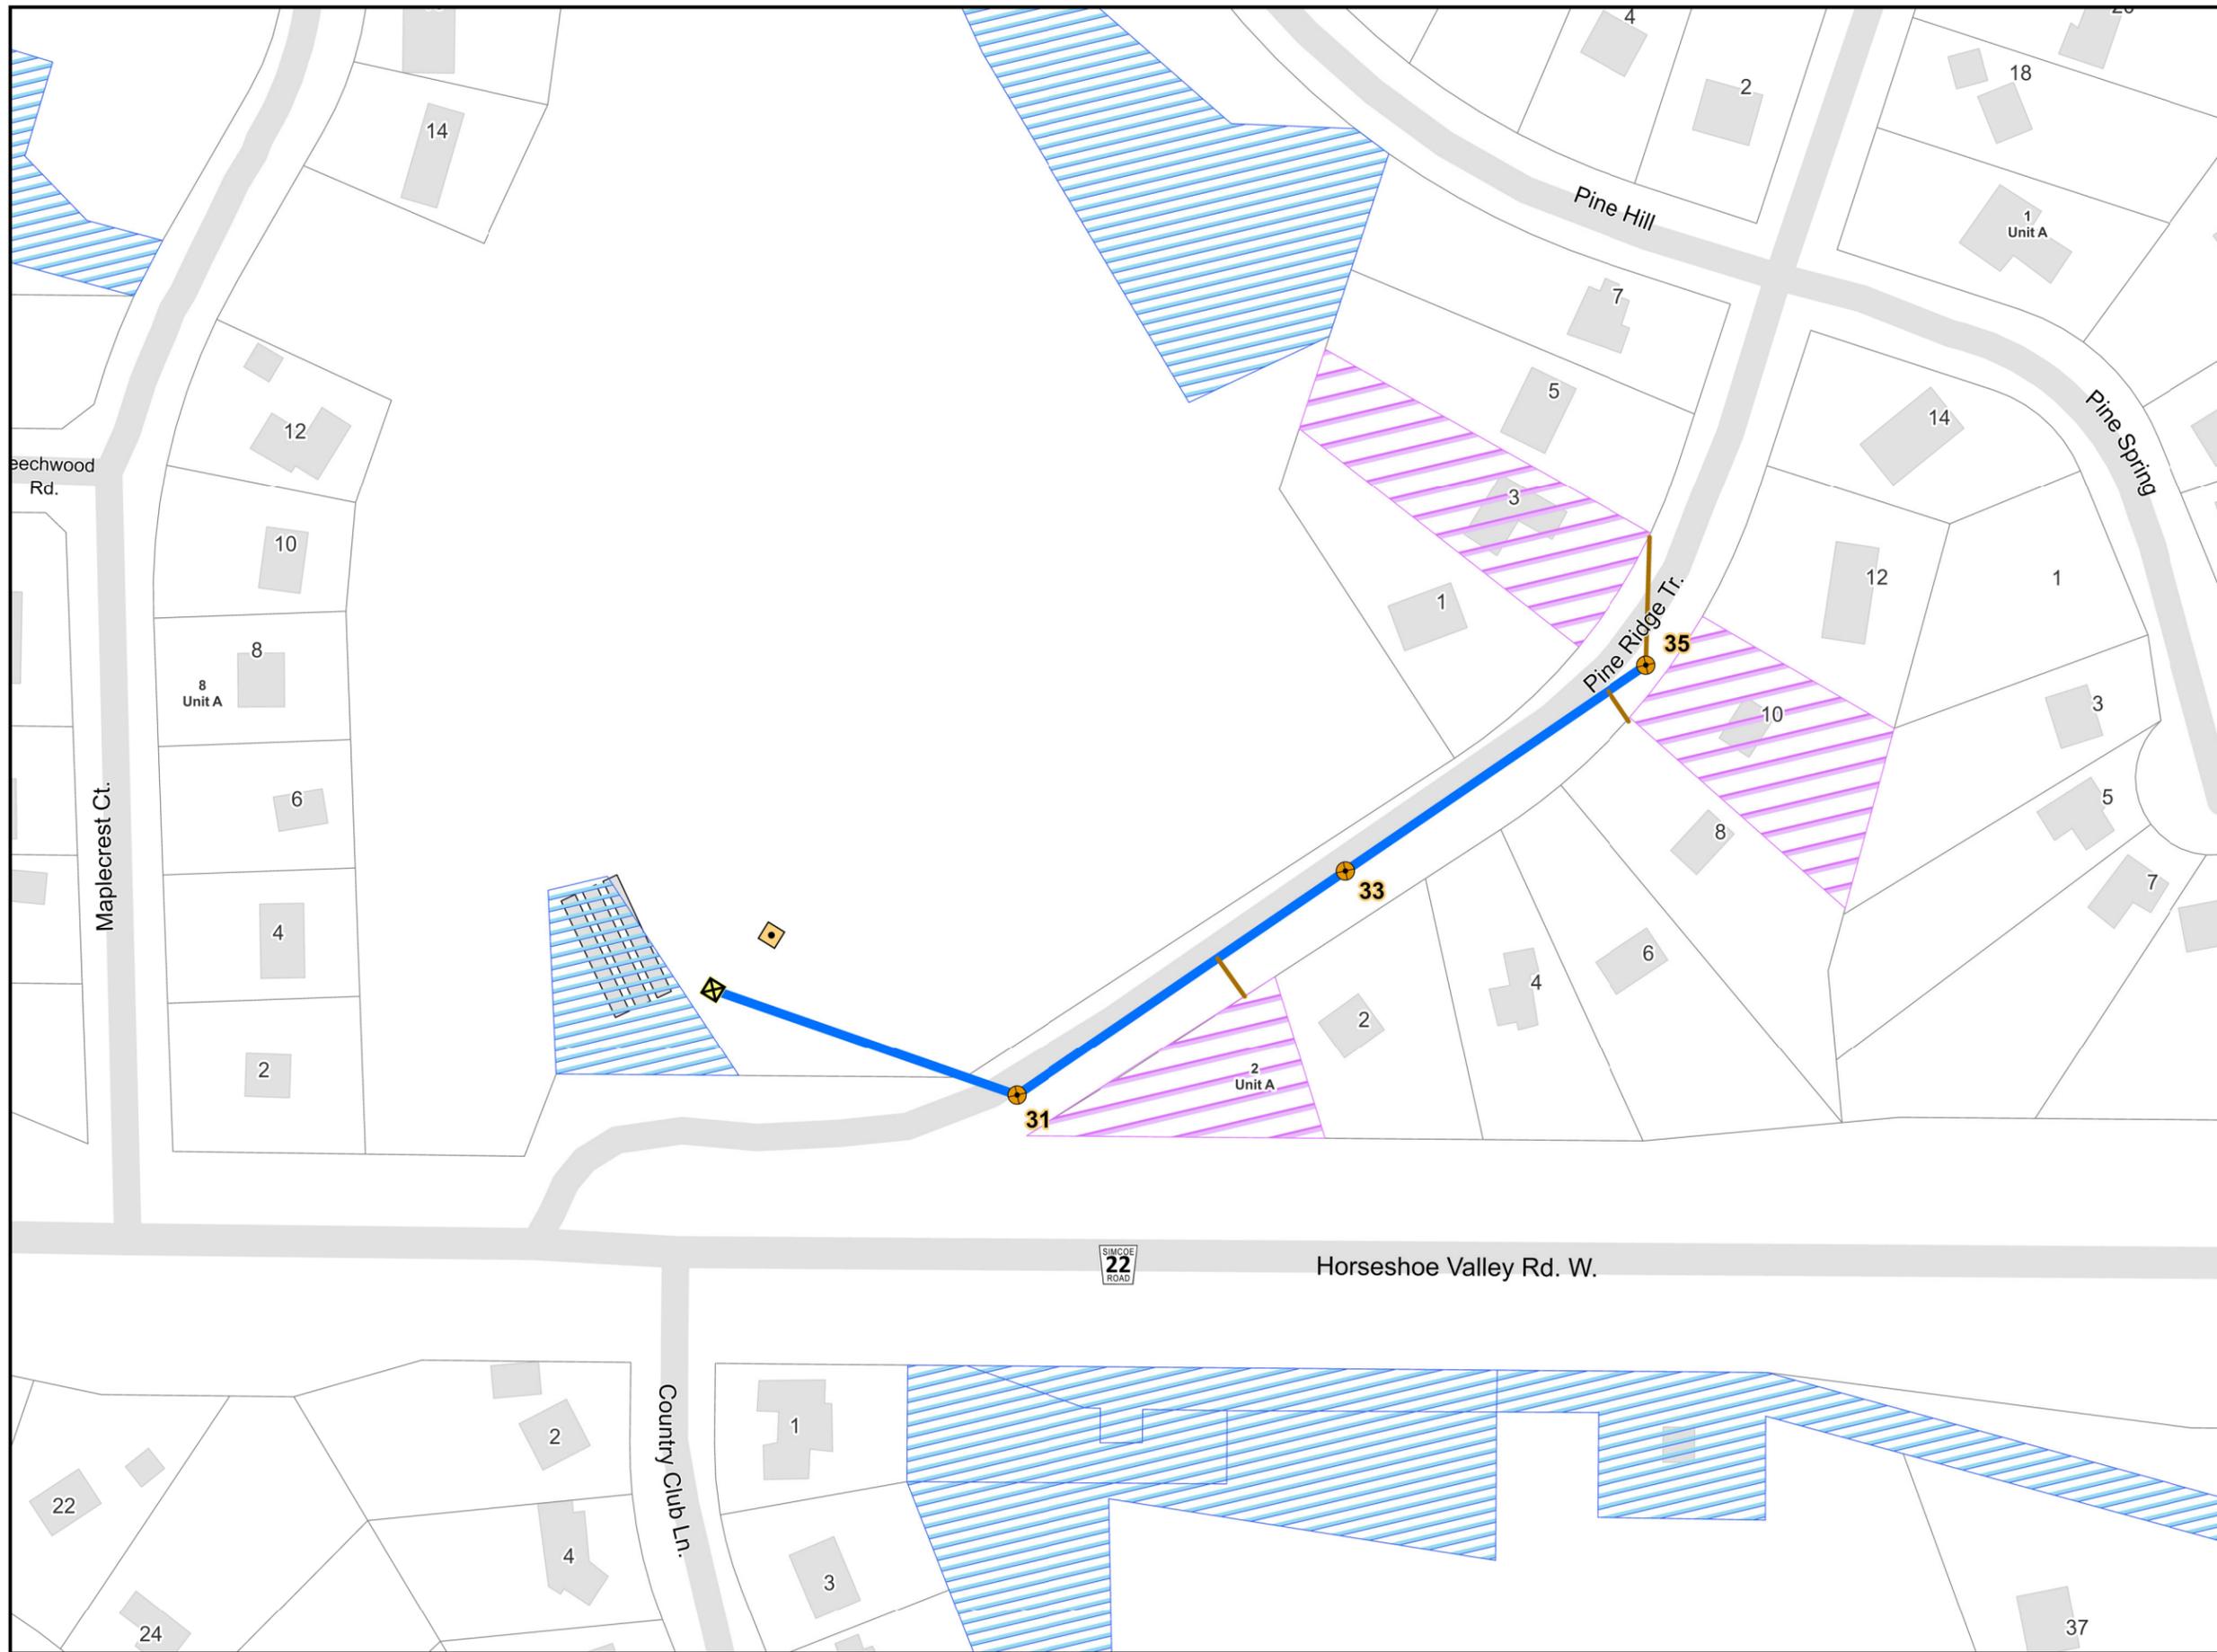
Wastewater System Plan
Tile Field 3
 January 2025

Communal Tile Field 3 is located behind 2 and 4 Maplecrest Court and services three (3) properties, each equipped with its own septic tank that provides primary treatment. Effluent from these private septic tanks flows into the associated municipal collection system and is conveyed to the communal tile field for subsurface disposal through a siphon/dosing chamber and leaching bed. The collection system includes approximately 257.6 m of gravity sanitary sewer main and 3 maintenance holes.

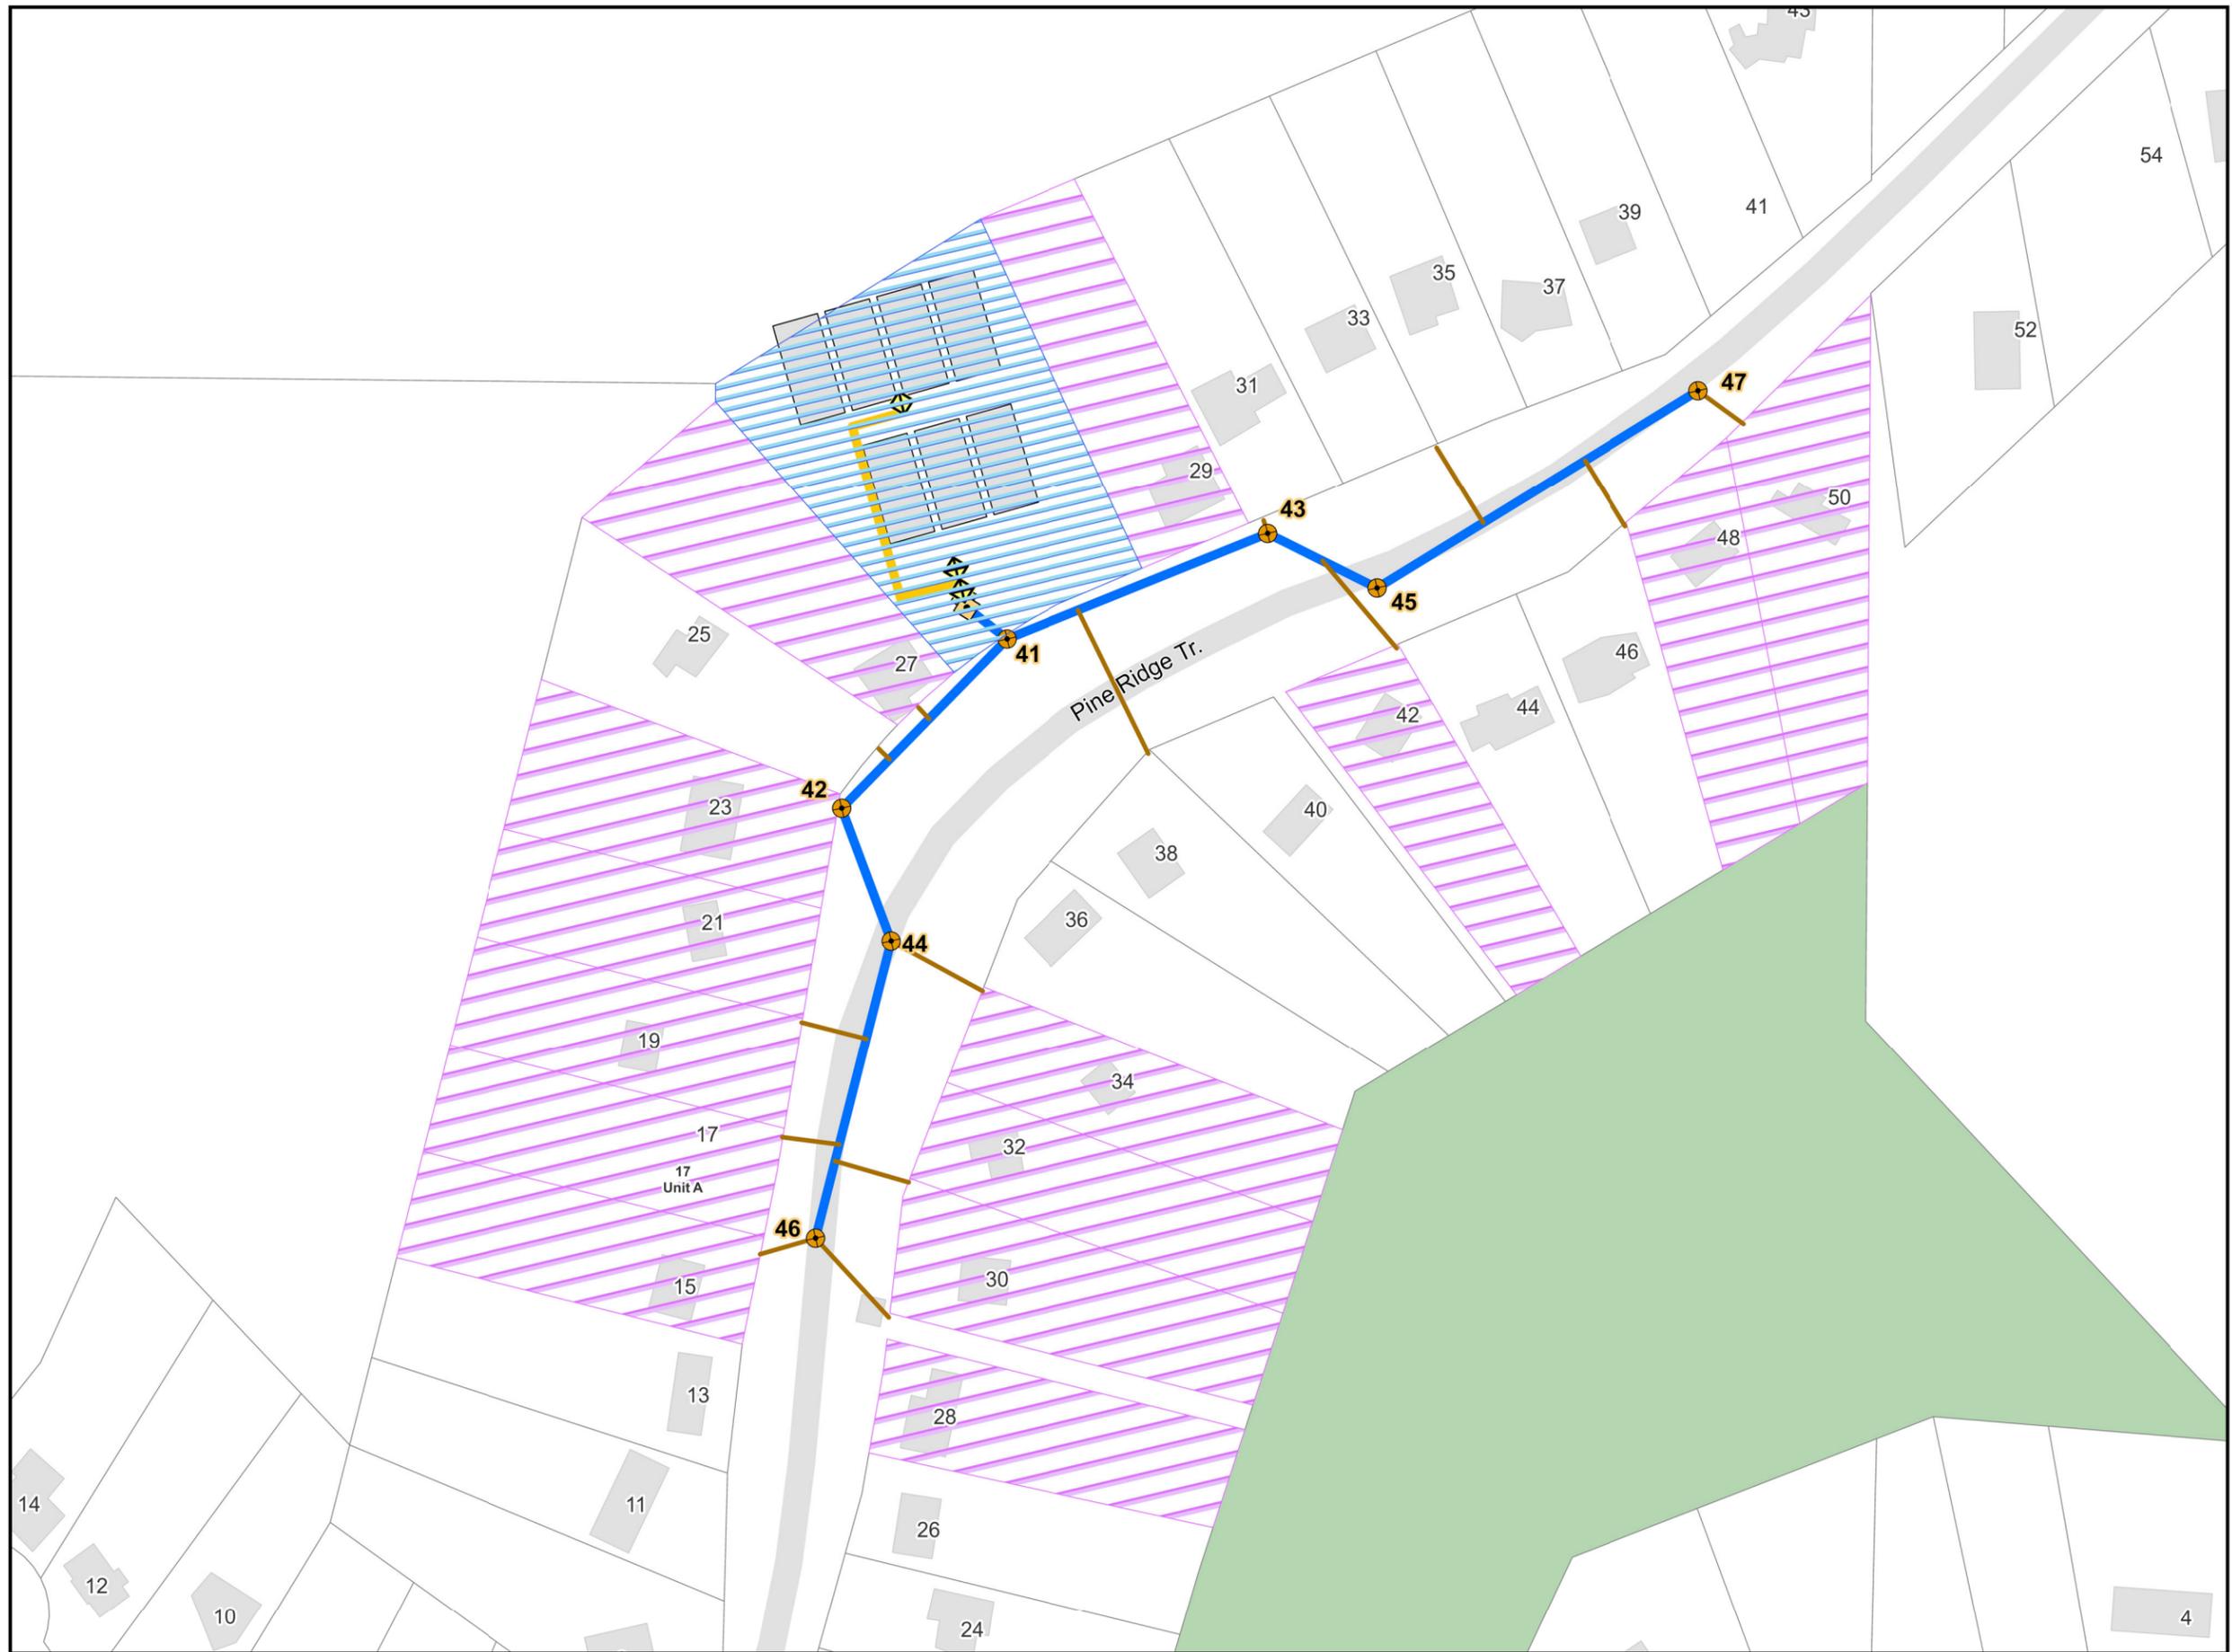
Wastewater System Plan
Tile Field 4
 January 2025

Communal Tile Field 4 is located between 27 and 29 Pine Ridge Trail and services fourteen (14) properties, each equipped with its own septic tank that provides primary treatment. Effluent from these private septic tanks flows into the associated municipal collection system and is conveyed to the communal tile field for subsurface disposal through a siphon/dosing chamber and leaching bed. The collection system includes approximately 442.7m of gravity sanitary sewer main and 7 maintenance holes.

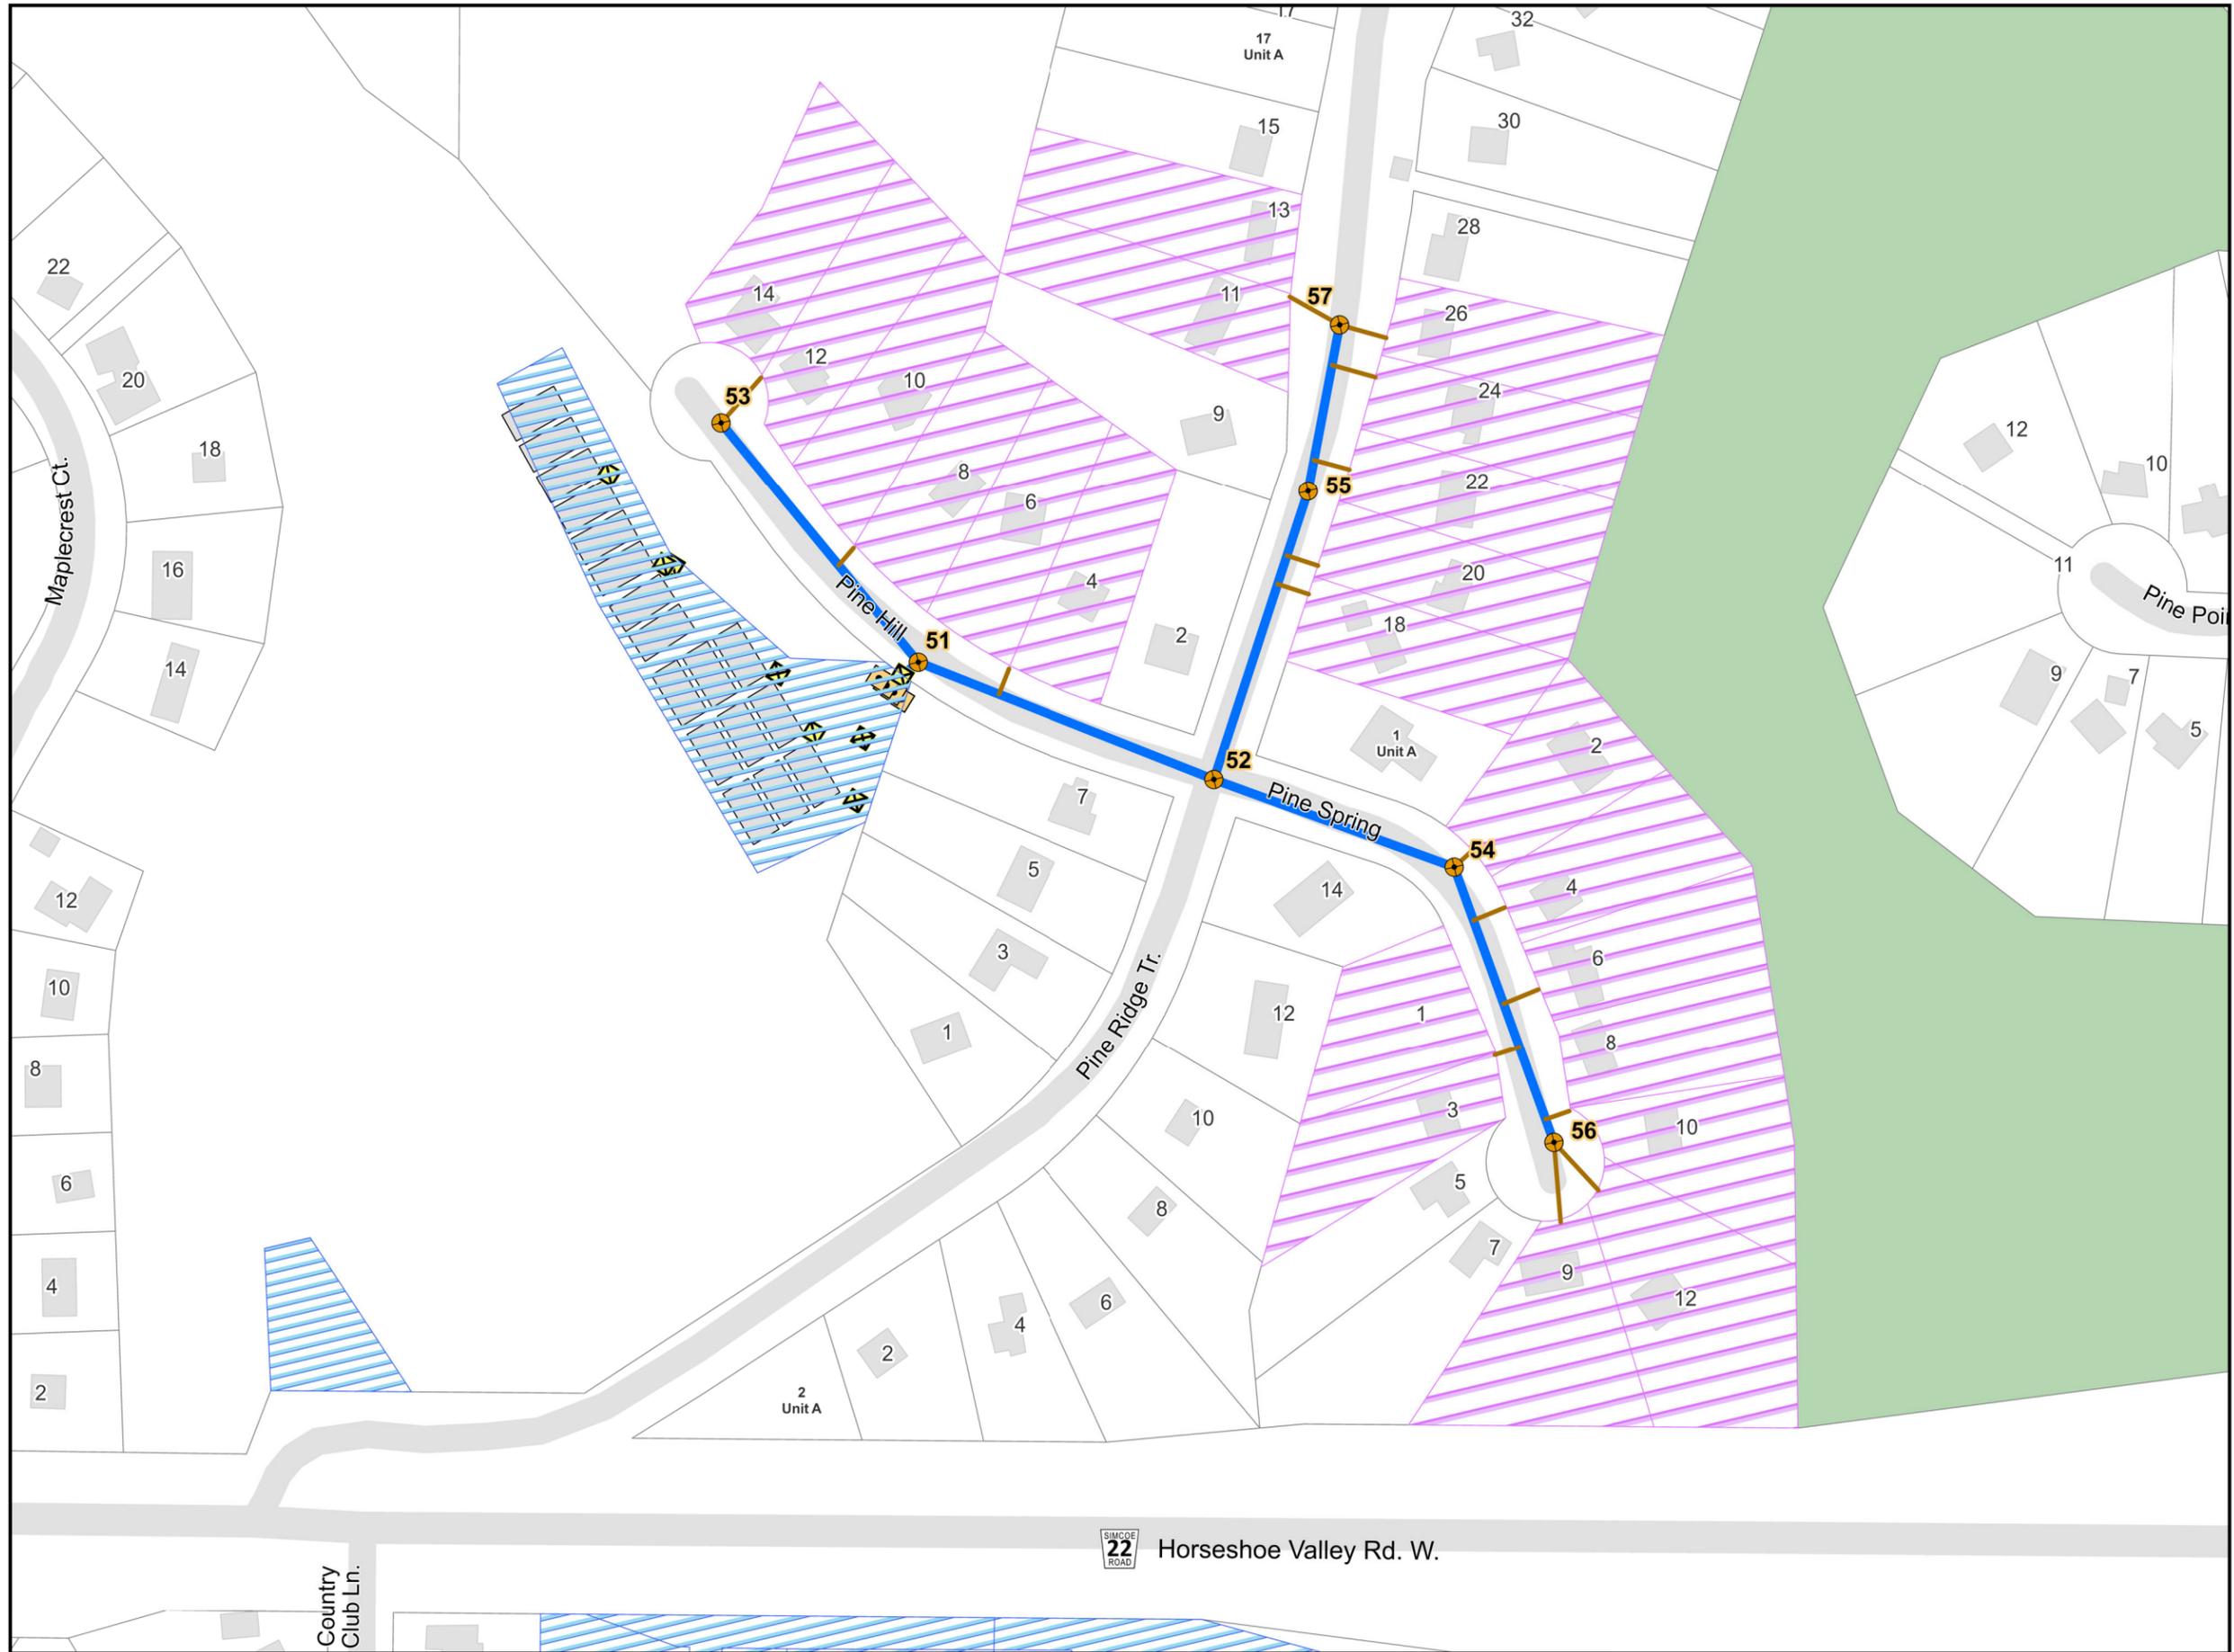
Wastewater System Plan
Tile Field 5
 January 2025

Communal Tile Field 5 is located behind 1, 3, 5, and 7 Pine Ridge Trail and services twenty-two (22) properties, each equipped with its own septic tank that provides primary treatment. Effluent from these private septic tanks flows into the associated municipal collection system and is conveyed to the communal tile field for subsurface disposal through a siphon/dosing chamber and leaching bed. The collection system includes approximately 515.6m of gravity sanitary sewer main and 7 maintenance holes.
