Township of Oro-Medonte Communal Tile Fields Performance Report 2025

Horseshoe Valley Municipal Communal Tile Fields & Sewage Collection Systems Annual Report

Period Covering: January 1, 2025 to December 31, 2025

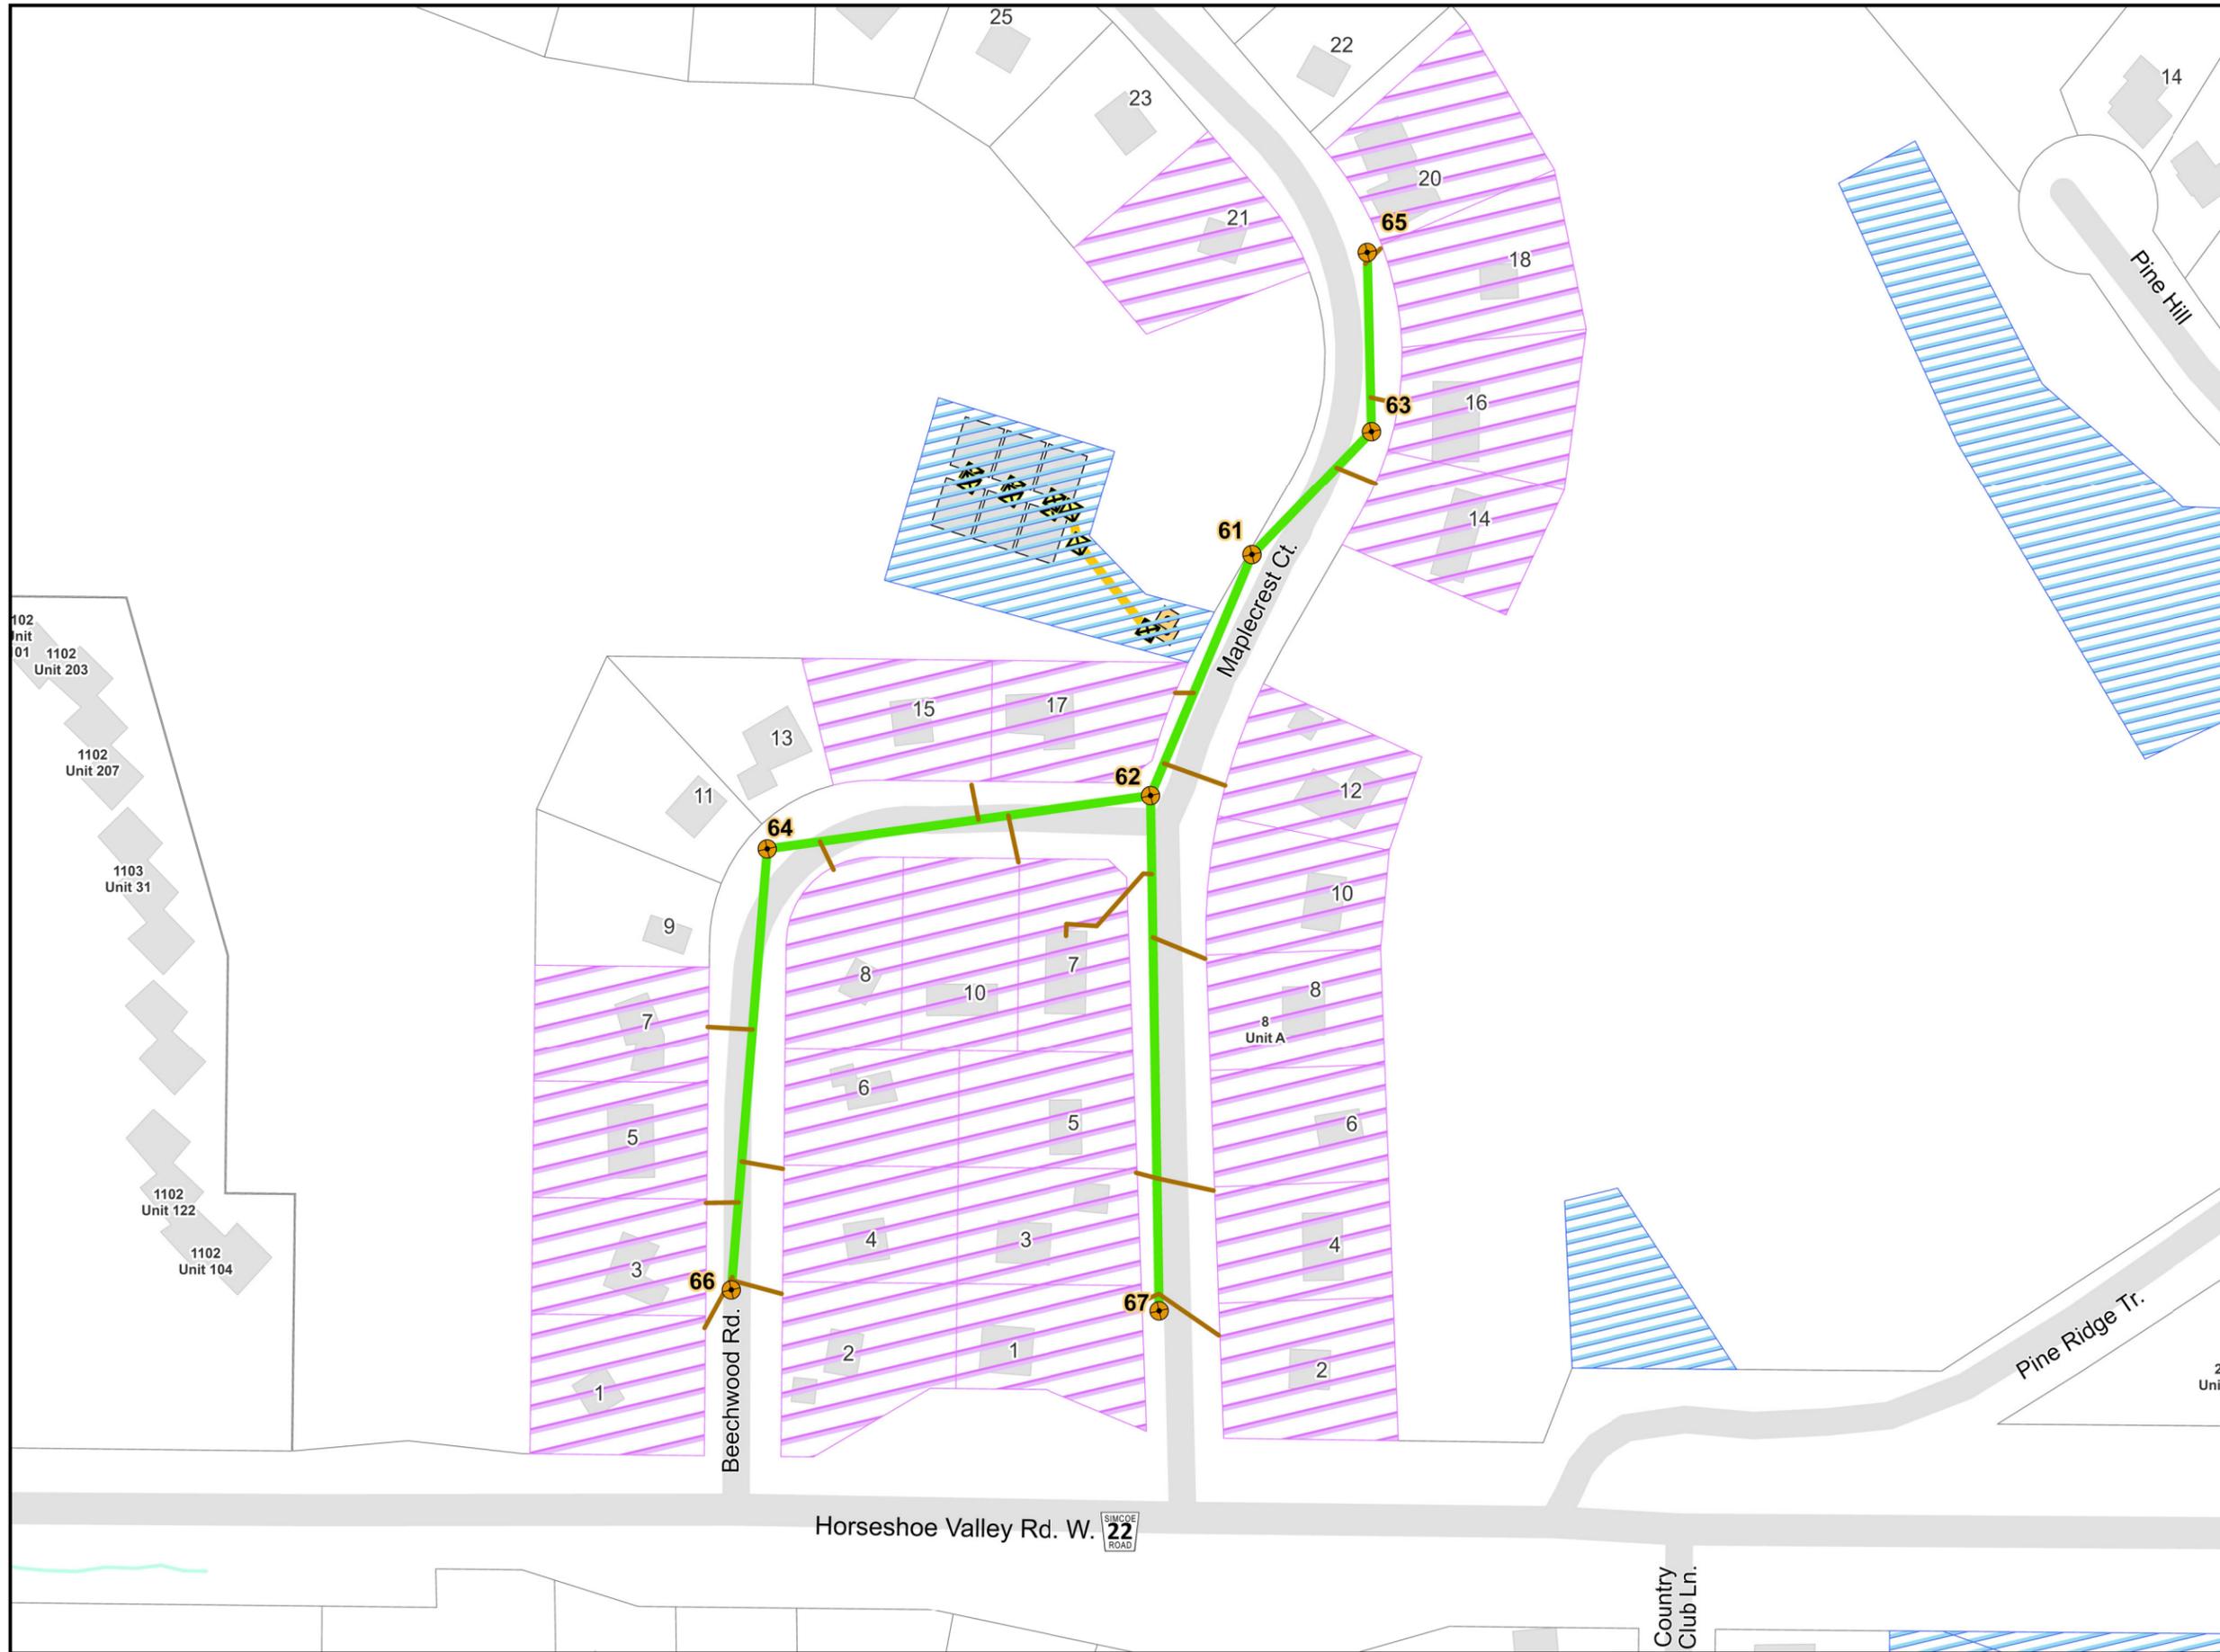
Wastewater System Plan
Tile Field 6
 January 2025

Communal Tile Field 6 is located behind 15 and 17 Beechwood Road and services twenty-six (26) properties. Unlike users connected to the other communal tile fields, these properties do not have individual private septic tanks. Instead, effluent flows directly from each property through the municipal collection system to a communal septic tank and then to a second septic tank, creating a two-stage treatment sequence before being conveyed to the communal tile field for subsurface disposal through a siphon/dosing chamber and leaching bed. The collection system includes approximately 559.6 metres of gravity sanitary sewer main and seven maintenance holes.

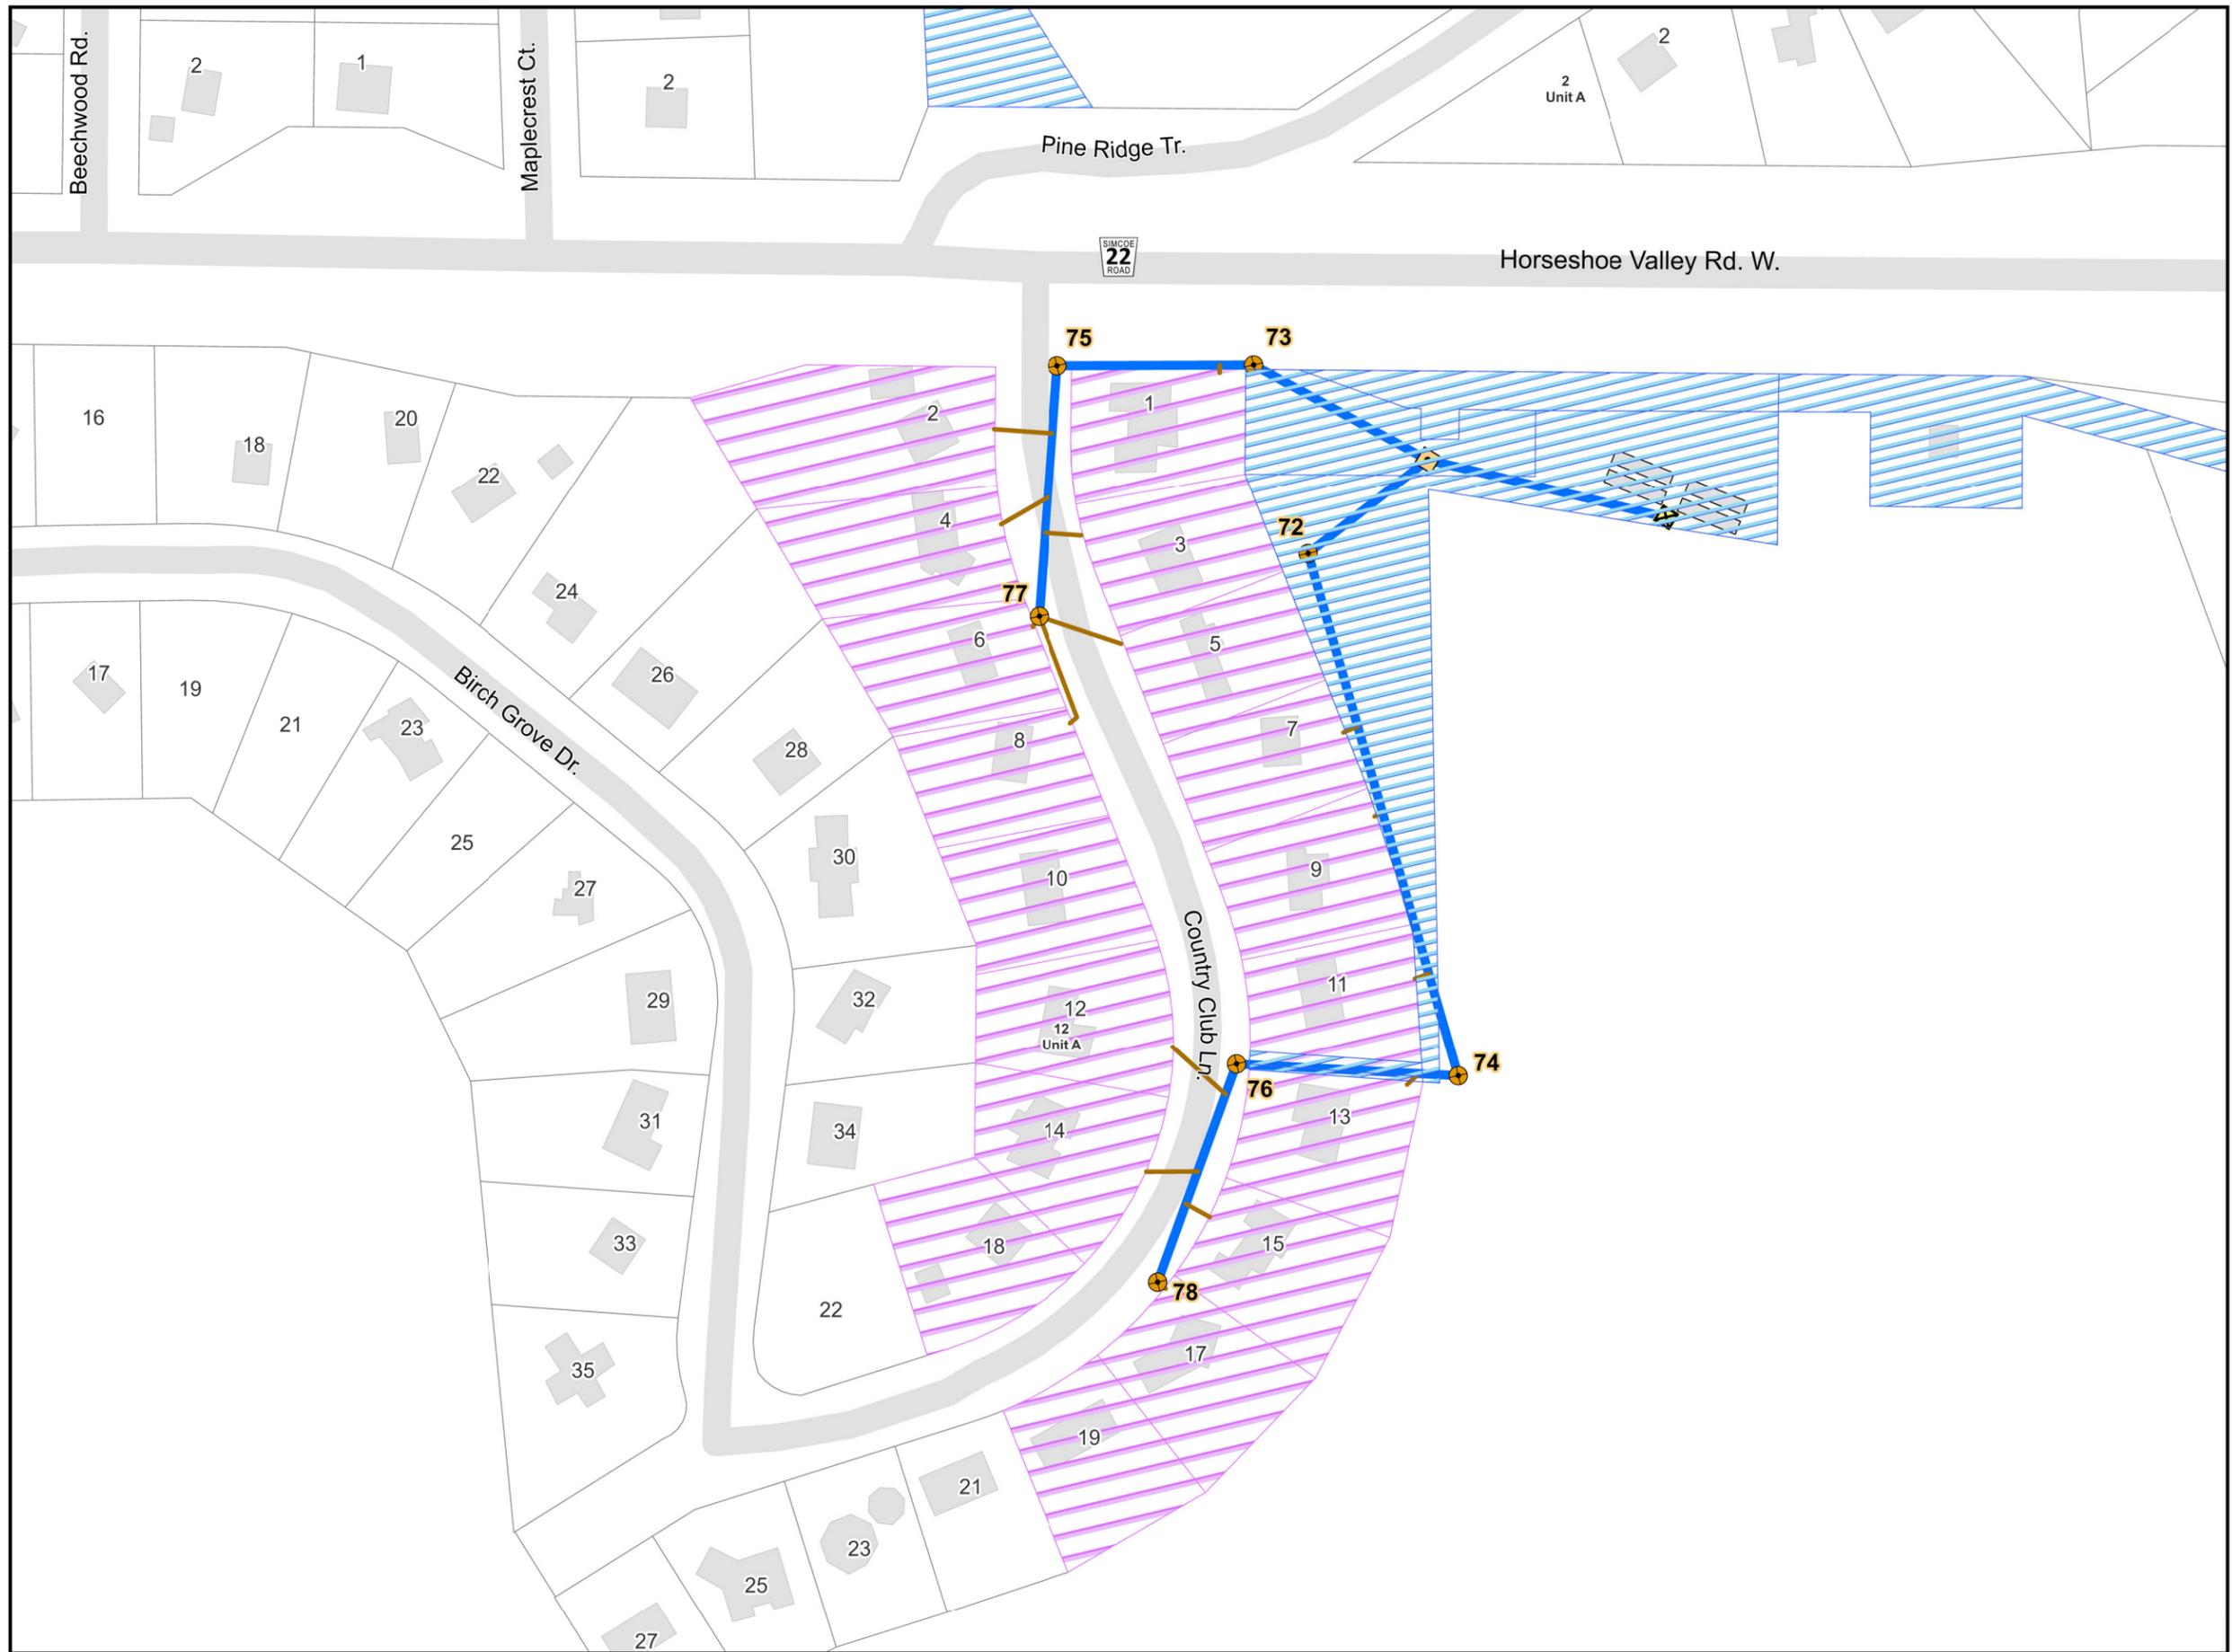
Wastewater System Plan
Tile Field 7
 January 2025

Communal Tile Field 7 is located south of the municipal water service road between Country Club Lane and Valleycrest Drive. and services eighteen (18) properties, each equipped with its own septic tank that provides primary treatment. Effluent from these private septic tanks flows into the associated municipal collection system and is conveyed to the communal tile field for subsurface disposal through a siphon/dosing chamber and leaching bed. The collection system includes approximately 535.7 m of gravity sanitary sewer main and 7 maintenance holes.
